# KEN SOBLE TOWER TRANSFORMATION

A CASE STUDY IN DEEP RETROFIT AND HOUSING RENEWAL

# KEN SOBLE TOWER TRANSFORMATION OVERVIEW

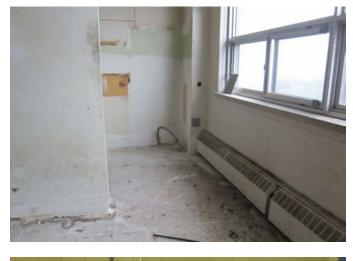
Pre-Renewal Conditions: Unit Living Room (Above) and Bathroom (Below)

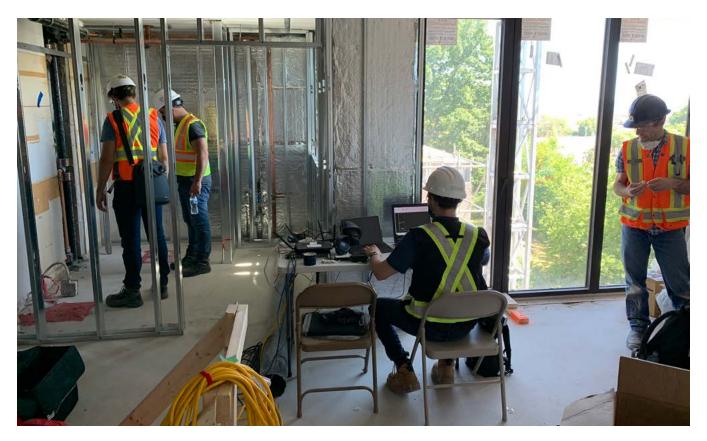
The airtightness testing plan was similarly broken into stages that aimed to identify and give an opportunity to resolve any problem areas prior to them being covered up by other work. Ultimately, only the final full building airtightness test (blower door test) is reported as part of the EnerPHit certification, however a series of interim blower doors tests of smaller portions of the volume of the building was also used. A blower door test measures the airtightness of a building by closing all windows and doors and using a blower door fan to pressurize and depressurize the building in order to measure the amount of air leakage through the envelope. In order to achieve EnerPHit certification, the building will be required to achieve an airtightness of 1.0 ACH @ 50 Pa. That is a maximum of 1.0 air changes per hour through the envelope when the building is pressurized to 50 pascals.

In-suite testing

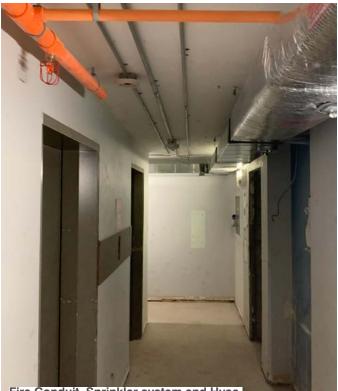
Fire Conduit, Sprinkler system and Hvac system installed in Corridor.

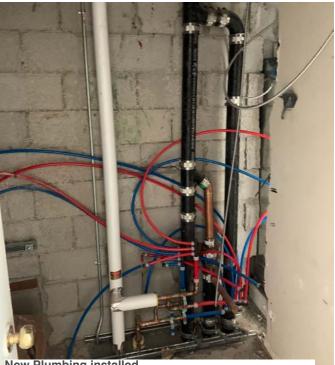
New Plumbing installed

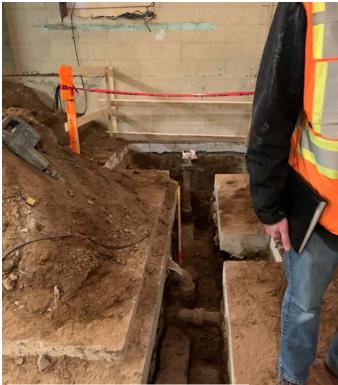
Ongoing cutting, trenching and excavation in the Mechanical Room in Block A.

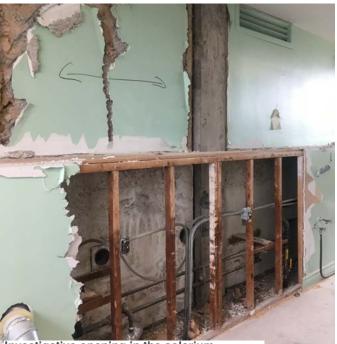
Investigative opening in the solarium
